Home Inspections by John

Confidential - Property Inspection Report - Confidential

, Wallace KS, 67761 Inspection prepared for: Inspection Date: 10/9/2010 Time: 0900 Size: 5200 Weather: sunny, 75 private treaty sale.

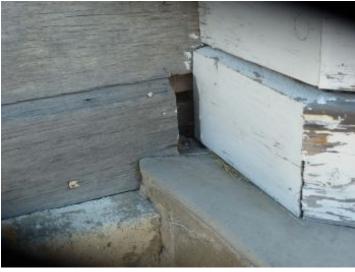
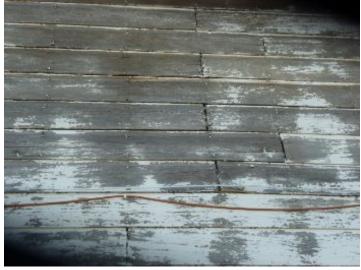
Exterior Surfaces House Covering/Siding

• There are areas of the siding that ares loose/damaged/warped. Water can infiltrate & damage the framing. Recommend repairing any loose or damaged areas. Priming, caulking painting, and some trim repair is needed

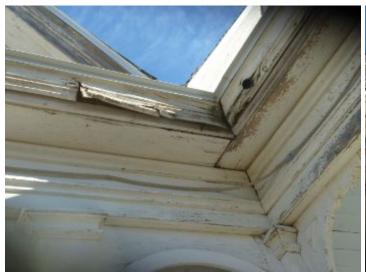
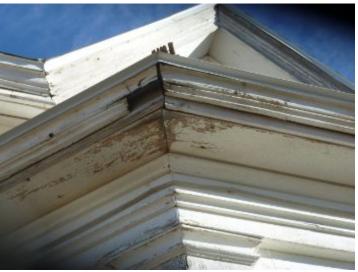
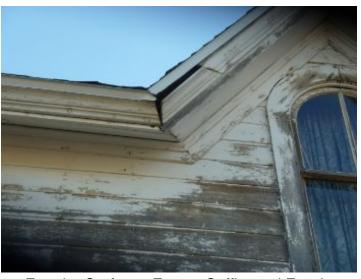
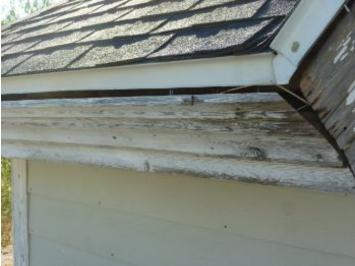
Exterior Surfaces Eaves, Soffits and Fascia

- Recommend attaching, prepping, priming and painting any exposed wood trim
 Warping
 Broken areas

- bird nests

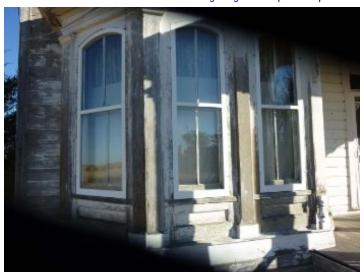
Window glazing needs repair or replacement

cracked glass

typical repair needed

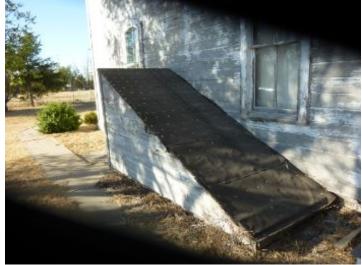
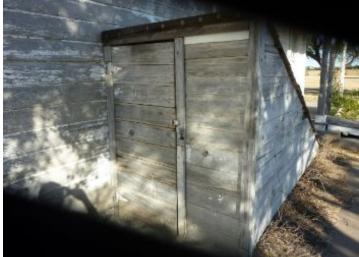
The outside basement entry is not a sound structure. I would suggest either a total new replacement entry way or you might consider closing the basement doorway and completely doing away with the outside entry. You might consider installing a new egress / exit window where the current doorway is.

replace entry

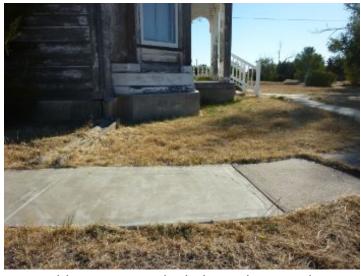
some low spots need filled and graded.

this corner needs drainage improved

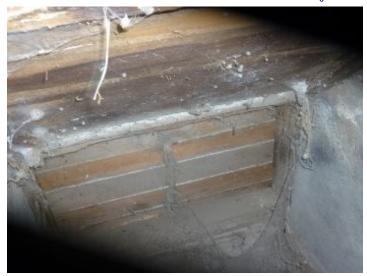
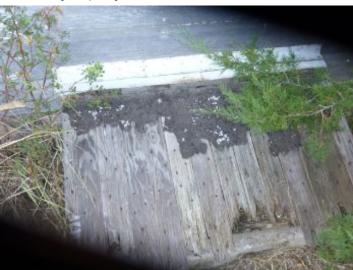
• The window well covers are damaged. Recommend removing or replacing

needs cover replaced

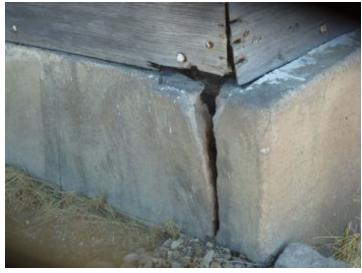
mortar crack, possible leak to interior

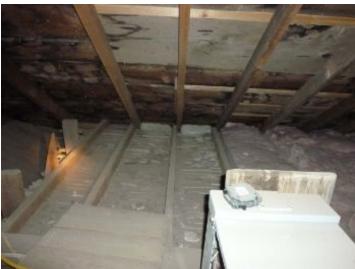
need to install missing insulation

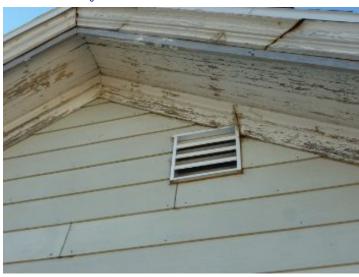
Attic Roof Ventilation

• Gable louver vents, only one.

Attic ventilation is marginal

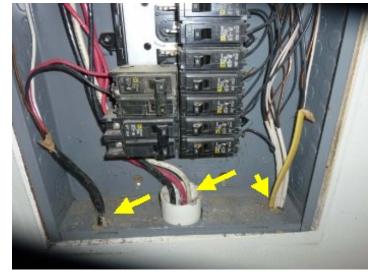
Electrical System Main Service Panel(s)

- see comment page and photos
 The wiring within the main panel appears to have been done by a home handyman. This is not necessarily unsafe but other wiring should be checked to determine its conformity to safe electrical standards.

missing strain relief

knockouts missing, safety issue

- Electrical: The breaker on the meter pole is 100 amp and the main breaker in the house is a 200 amp. Normally the higher rated 200 amp breaker would be on the meter box breaker. The main breaker box in the kitchen area should have some strain relief clamps to protect the wire from the sharp edges on the breaker box and the inside cover should be replaced because of the breaker knockouts missing creates a safety issue. The sub panel in the attic should have been installed in a hallway where there would have been easier to access and where it could be easy to find. The sub panel in the attic and the one in the basement should have the covers installed.

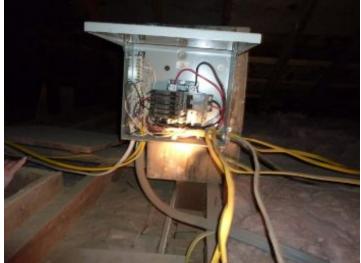
in attic #2, Install cover

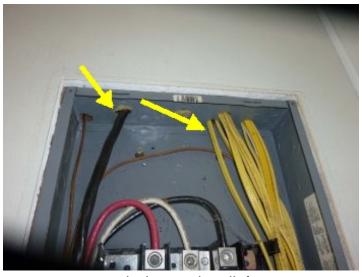
Satisfa ctory	Margin al	Poor	Safety issue	N/A	Materials: Wiring type: non-metallic sheathed cable "Romex"
	Х				Observations: • Amateur wiring in evidence
					 Visible wiring appeared functional, at time of inspection.

missing strain relief

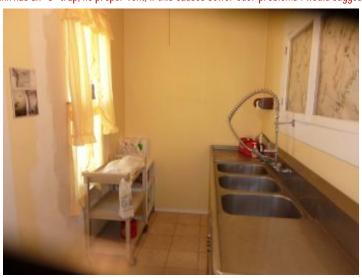
sink area

- Sink is in satisfactory condition
 faucet is in satisfactory condition
 sink has an "S" trap, no proper vent, if this causes sewer odor problems I would suggest installing air admittance valves.
